NACA RM E53G02

PRELIMINARY INVESTIGATION OF SEVERAL ROOT DESIGNS FOR
CERMET TURBINE BLADES IN TURBOJET ENGINE

II - ROOT DESIGN ALTERATIONS

By A. J. Meyer, Jr., G. C. Deutsch, and W. C. Morgan

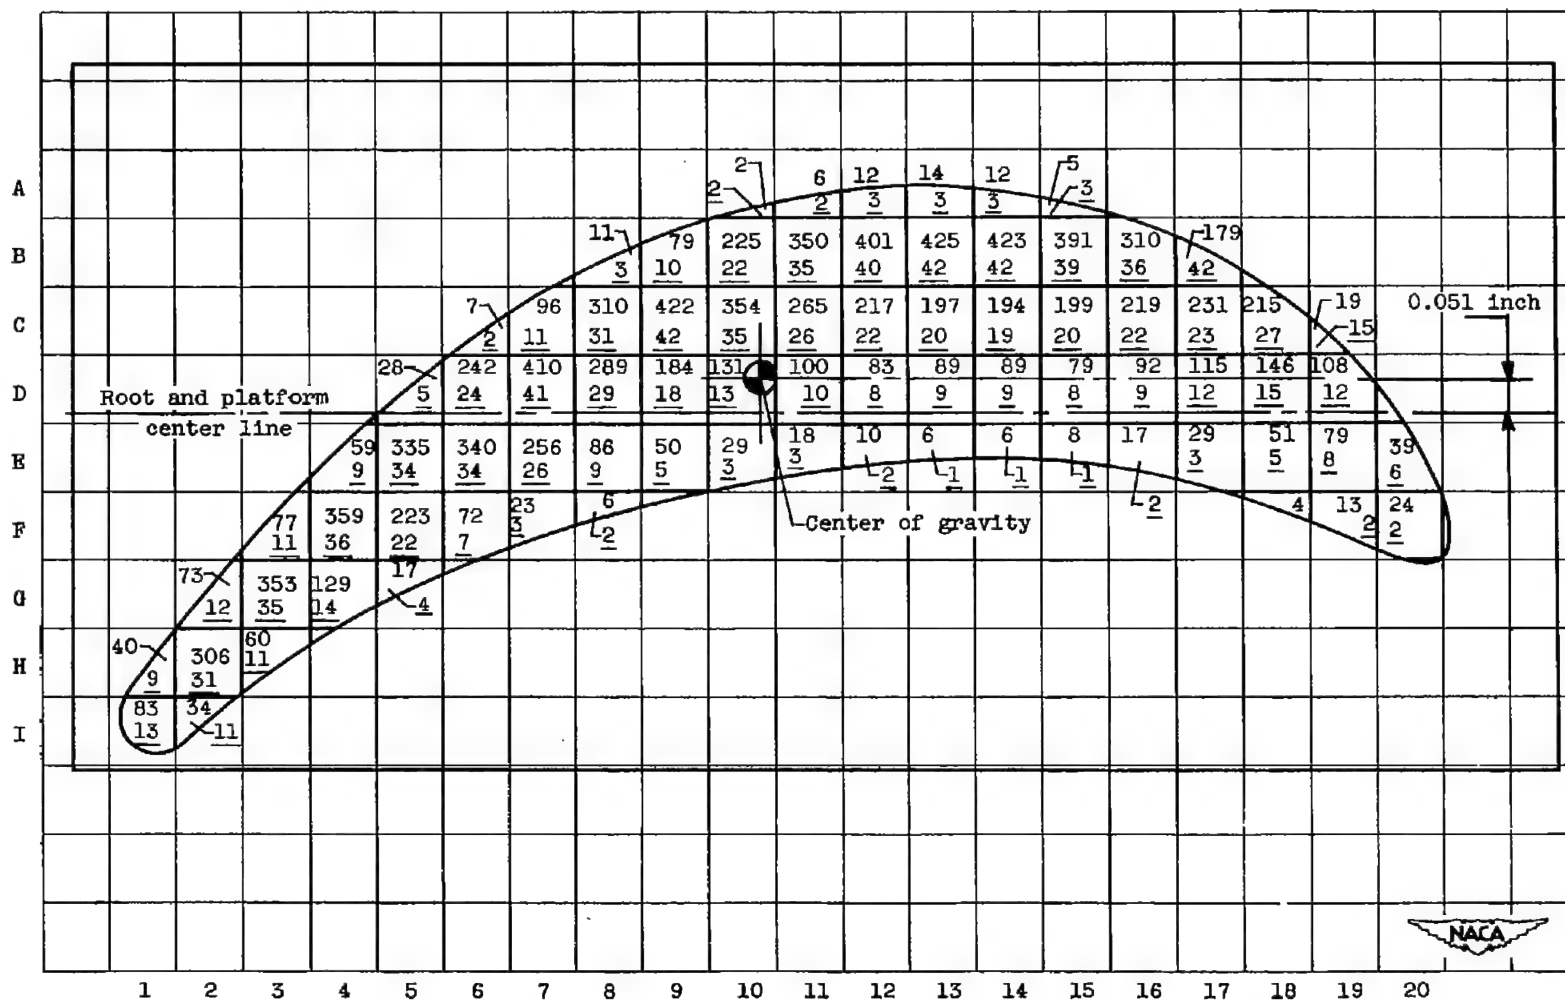
Results of calculation. - The results of the calculations are shown in figure 10. The upper numbers in each square are the total centrifugal forces in pounds acting on each square and the lower numbers (under-scored) are the stresses (in 1000-psi units) that would be acting on the base plane squares if each column were cut free from its neighbors. Actually, there would be a gradual variation in stress from one square to the next. From the magnitude of the numbers presented and their location, it is obvious that the greatest centrifugal loads and stresses are in the region where most of the failures originated. The location of the radial projection of the center of gravity of the whole airfoil is determined by dividing the summation of moments of the centrifugal force of the individual columns times their distance from an arbitrary axis by the summation of the centrifugal forces.

Effect of offset center of gravity. - The procedure described shows the projection of the center of gravity on the base plane to be displaced 0.051 inch in the direction of rotation from the center line of the blade platform and root. This offset introduces a sizable bending moment in the blade root which is only partly compensated for by the gas forces on the airfoil. The gas force per blade as determined in the appendix of this report is 100 pounds at rated speed and

Figure 10. - Centrifugal force and stress distribution at base cross-section of airfoil.

The bending stress resulting from this computation is ± 6990 pounds per square inch. If then the airfoil is shifted 328 divided by 11,300, or 0.029 inch, in the tangential direction toward the concaved or pressure side of the blade, this bending stress can be virtually eliminated.

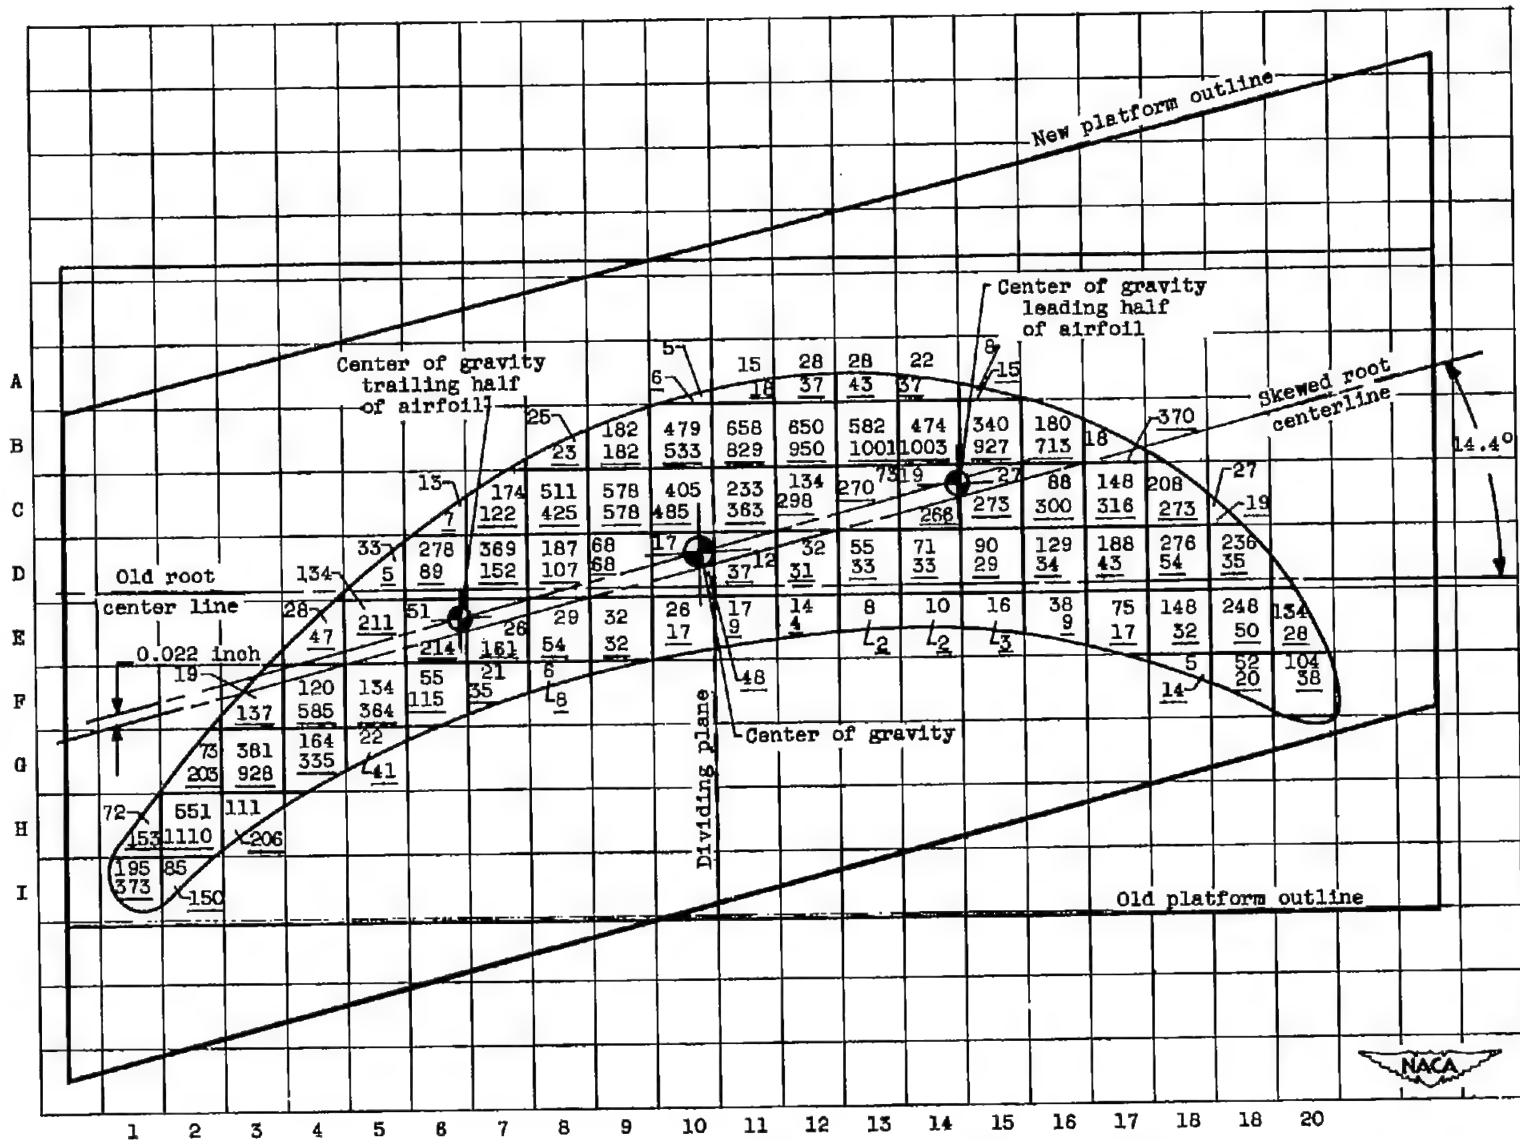
Effect of skewed root. - The largest number with the old center line is 1110, square 2-H, which might intimate that failure should have started in the root below the trailing edge. However, surrounding values are considerably less and thus would tend to reduce the peak stress at this location. The second largest number with the old center line is 1007, square 13-B, and is flanked by similar high values and therefore would be expected to influence the point where the root failures originated. The actual failure did start in this area.

The largest number with respect to the new center line is 658 (square 11-B), or appreciably less than the largest with the old axis. The 1110 value is reduced to 551, or by about one half. The 1007 value is also about halved, or is 582. The values in the vicinity of the leading edge are multiplied four or five times, but the values are still relatively low because the leading edge of the airfoil is swept back rapidly as the distance from the turbine axis increases. Consequently, skewing the blade root with respect to the airfoil and turbine axis should prove very beneficial.

Figure 11. - Relative bending moment comparison for standard and skewed roots.

Determination of skewing angle. - The skewing angle was established by finding the centers of gravity of the leading and trailing halves of the airfoil. Assume that the blade is cut lengthwise by a dividing plane through the midchord points and perpendicular to the turbine axis. Then the radial projection of the centers of gravity of each half on the base plane can be readily calculated from the previous computations, and a line drawn through these centers was used to determine the skewing angle, which in this case is 14.4° (see fig. 11).

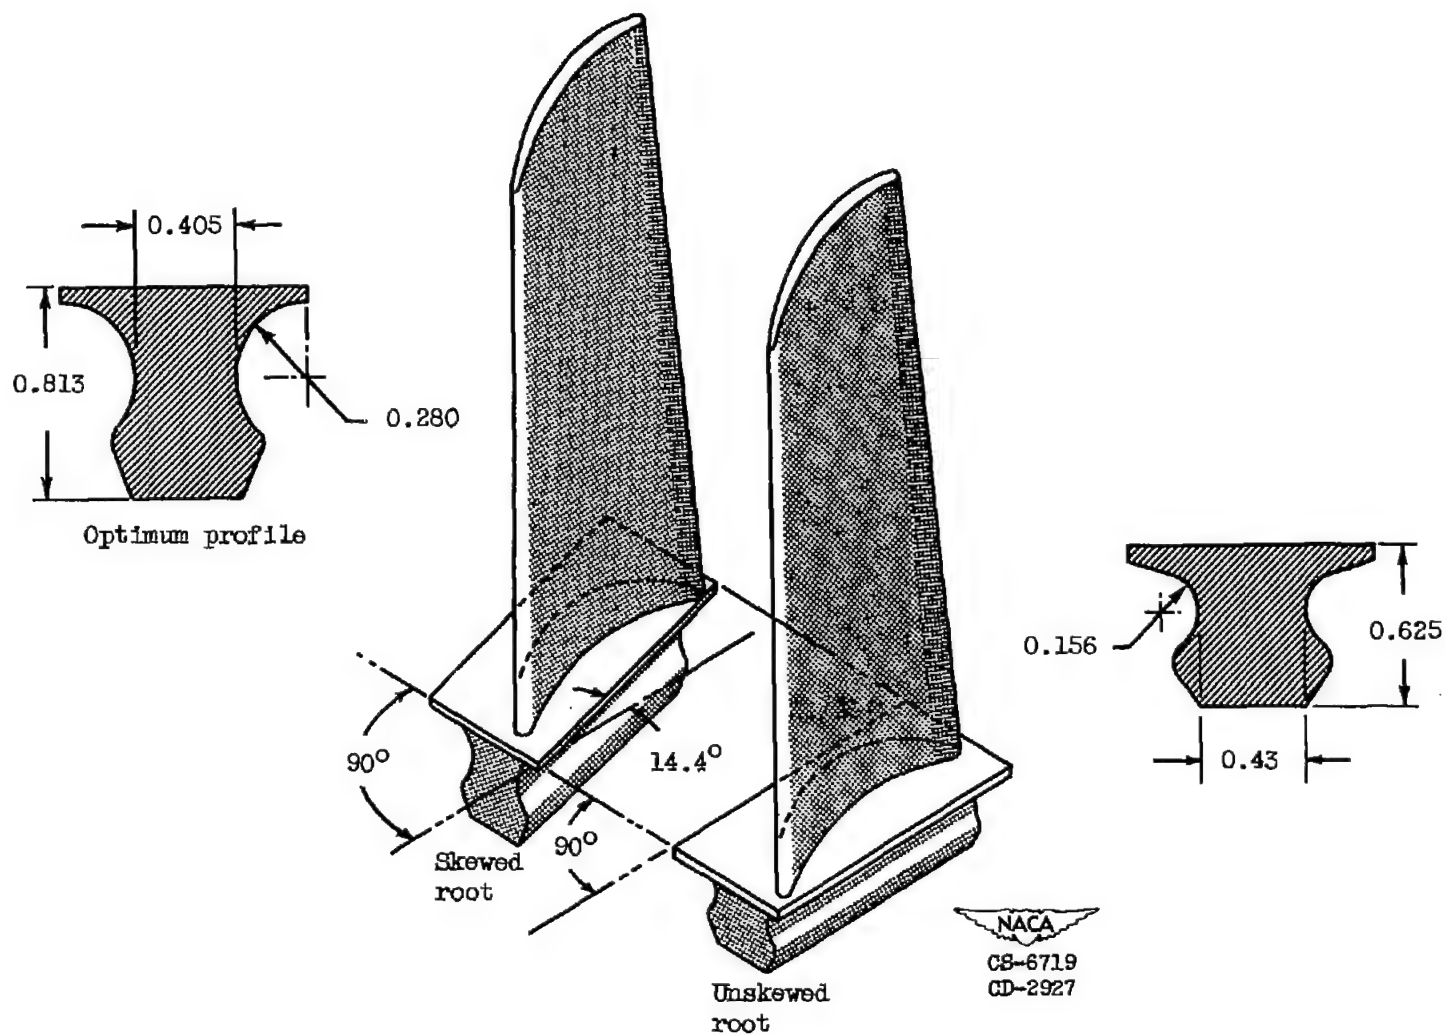
Figure 12. - Dimensions of standard and skewed dovetail cermet blades. (All dimensions are in inches.)

The results of a separate investigation on root profile design are reported in reference 2. In this reference optimum root proportions were determined to give maximum strength in pure tension. The experimental failure load for the small-radius dovetail profile is 37,190 pounds. When the optimum proportions of reference 2 are used, the same load is 41,220 pounds, or an improvement of 11 percent, as established by tensile tests of cermet specimens at 1200° F, reference 4. The increase was caused by a decreased stress concentration factor resulting from increasing the notch radius in the root from 0.156 inch to 0.280 inch. The neck distance in the root had to be reduced from 0.438 inch to 0.405 inch to accommodate the larger-radius root; nevertheless, it is stronger as a result of the lower stress concentration factor. The new root including both the skewing and the new profile is sketched along with the earlier dovetail for comparison in figure 12.

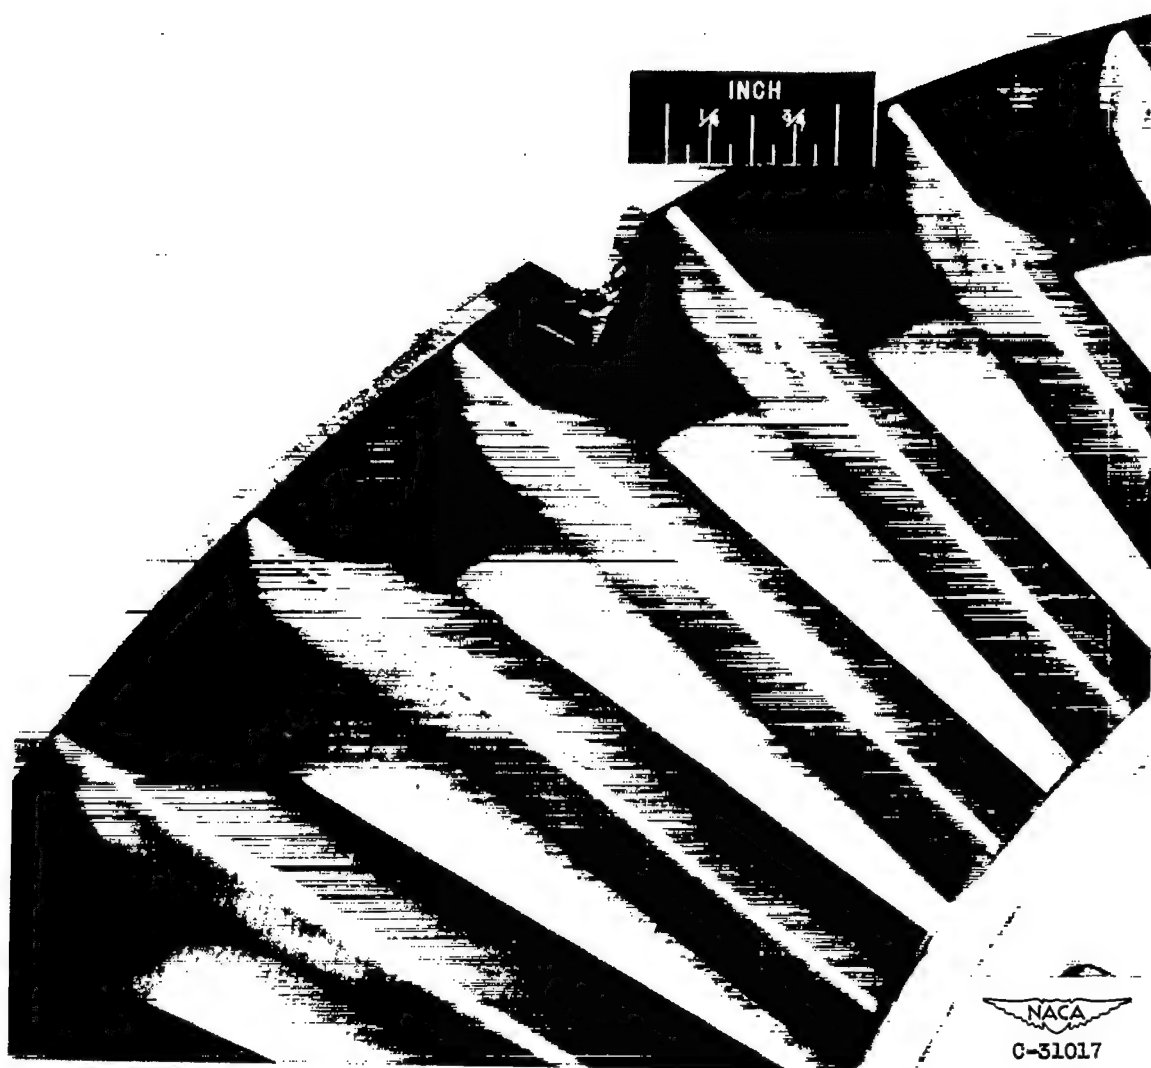
Run 14. - The engine with the new blades ran 112.5 hours before disassembly for over-all inspection. Run 14 and all previous runs with cermets were run with slightly opened tail cone because other engine parts cannot withstand continuous operation at rated power and speed, 11,750 rpm. Rotational speed and not power is the most important criterion determining the life of cermet blades. However, to include any additional effects that may be precluded by the limited power operation, the same four cermet blades were next operated at full power for 17 hours, at which time the nozzle diaphragm shroud failed and broke the cermet airfoils (fig. 13), completing run 14 of table I. Figure 14 shows the missing piece of the shroud band which passed through the turbine. The tail cone assembly had to be replaced frequently during the full-power operation and also the combustion-chamber tube assembly was excessively cracked.

Figure 14. - Nozzle diaphragm failure which caused airfoil failures; run 14.

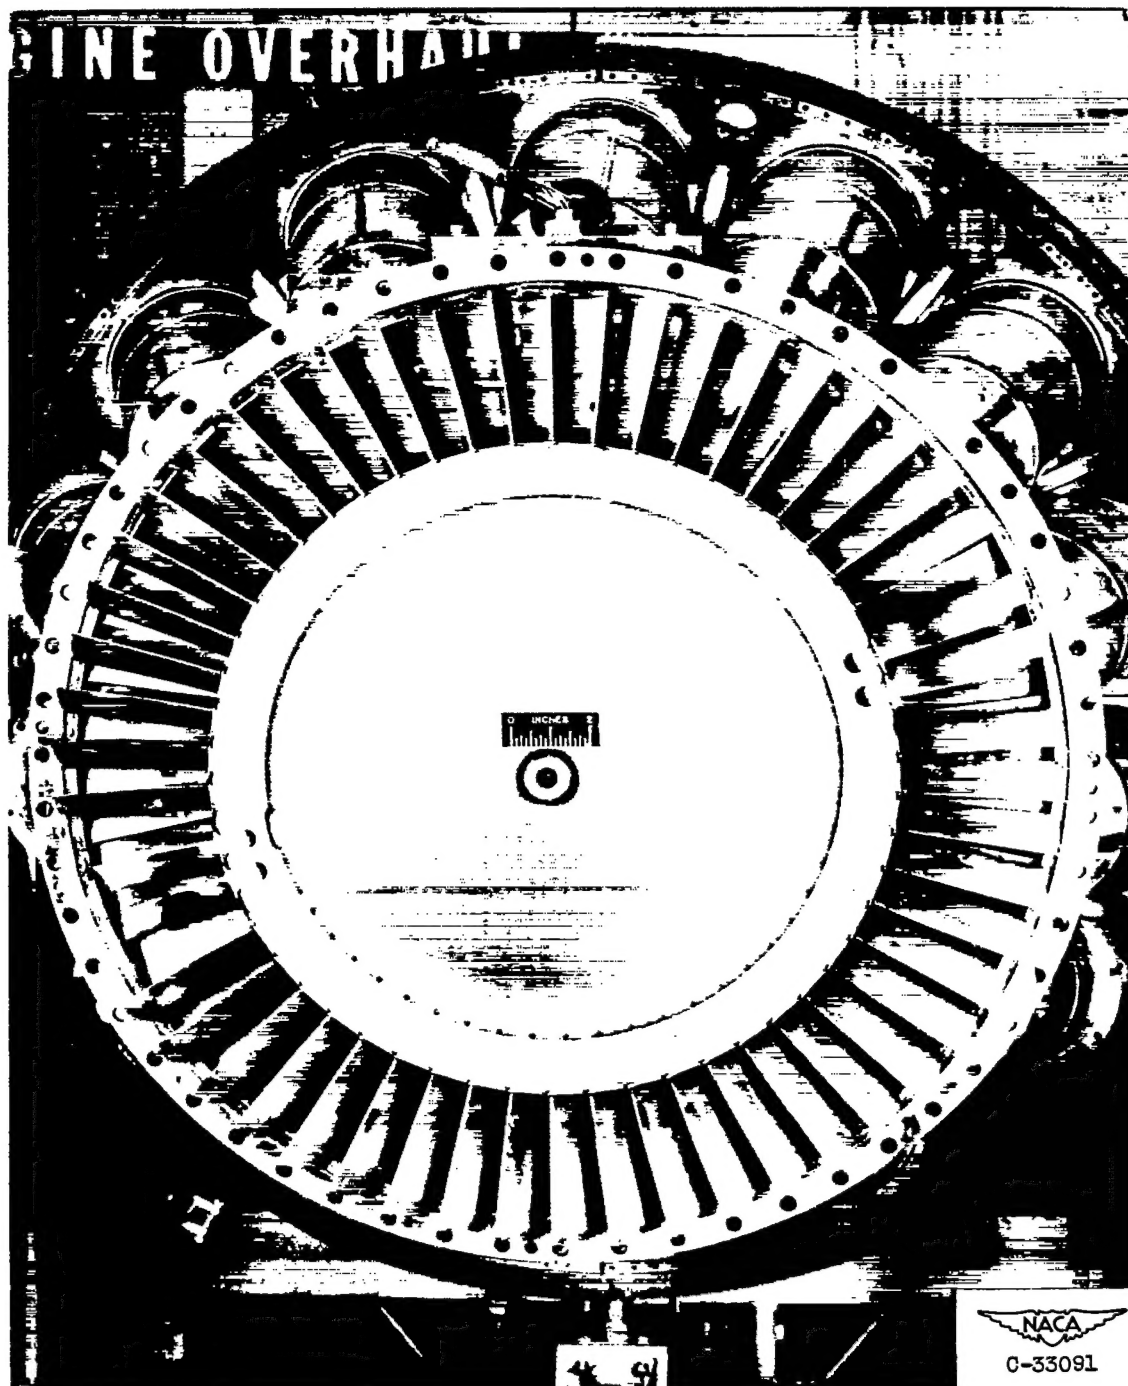
Run 17. - To evaluate the foregoing hypothesis concerning notch radii differences, four skewed-root blades were inserted in a new turbine wheel, two of the large-radius profile on one side of the wheel and two of the small-radius profile on the diametrically opposite side. The intention in run 17 was to run the engine 50 hours at rated speed and power (closed tail cone) and then proceed with cyclic operation. The engine ran 36 hours before the blades were damaged (fig. 17)

as a result of fatigued fragments breaking loose from the combustion domes and liners and passing through the turbine. Even though no cyclic operation was obtained to evaluate the effect of thermal expansion and contraction on the different radii, sufficient operating time was obtained at full power to indicate that probably the displacing and skewing of the root, and not the change in profile, were the primary factors leading to increased blade life.

Figure 17. - Failure of airfoils resulting from fatigue of combustion domes and liners; run 17.
